# Metallurgical Investigation into an Automotive Fire

W. Reitz

Failure analysis requires many forms of investigations; some are straightforward and others are conducted to eliminate alternate possibilities. This failure investigation occurred during a litigation assignment several years ago and concerned a recreational vehicle (RV) that caught on fire, killing one of the owners. It was important to identify the origin of the fire, and this paper describes how metallurgical analysis helped in determining that origin.

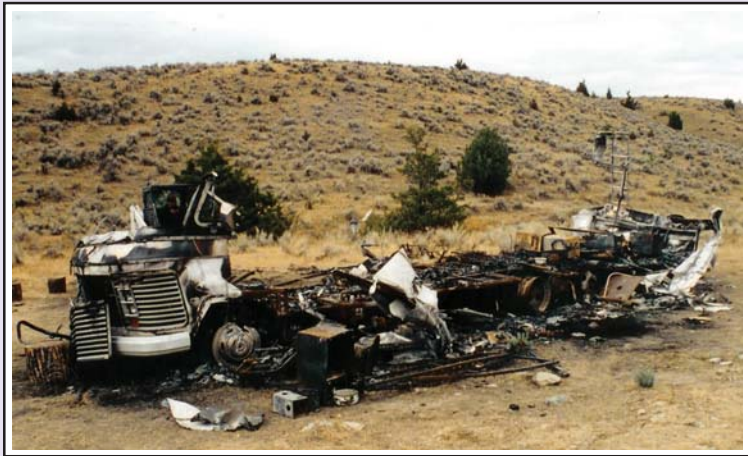
Fig. 3 Burnt recreational vehicle

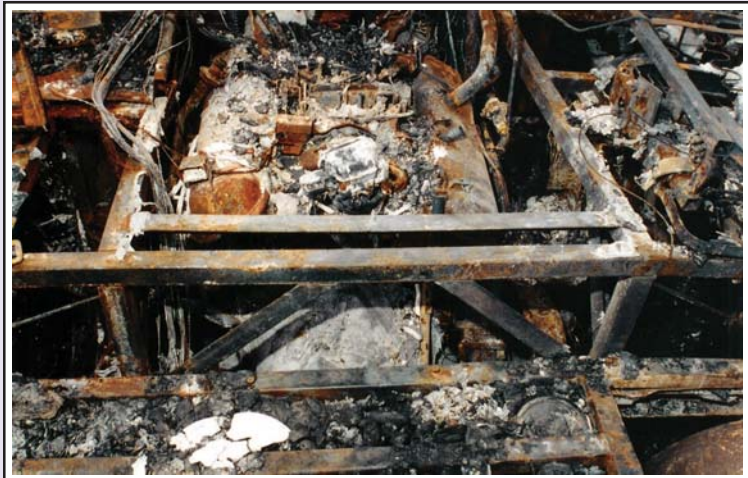
Fig. 4 Engine compartment

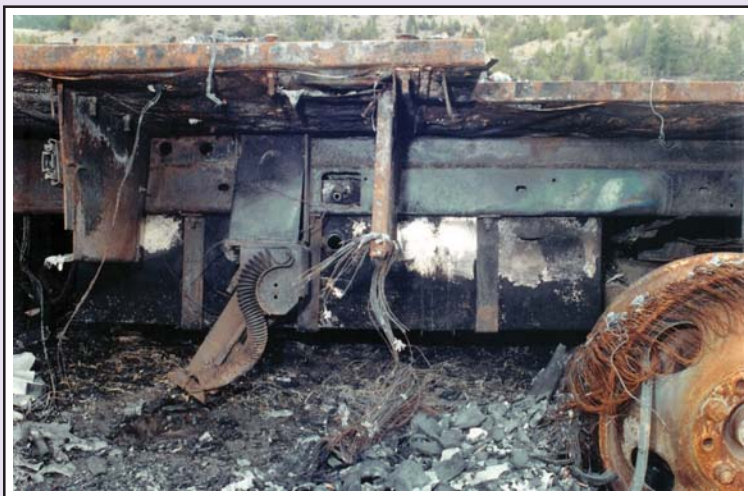
Fig. 5 Liquid propane tank and control valves

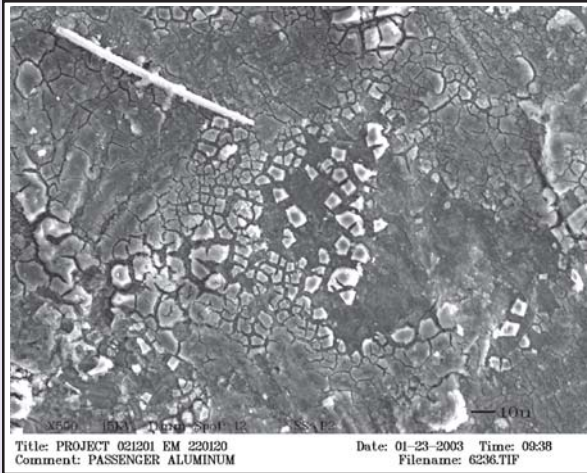
The melting and nominal recrystallization temperatures for aluminum are 660 and 100 °C (1220 and 212 °F), respectively. The temperature of the aluminum siding near the passenger's seat was approximately 648 °C (1200 °F). The temperature of the aluminum siding near the driver's seat was approximately 93 °C (200 °F) but did not approach the passenger side temperatures. This was established by noting excessive oxidation of the aluminum. Indications of high temperature (as determined via SEM, Fig. 6, and EDS) included the presence of porosity (Fig. 7) and incipient melting (Fig. 8) on the passenger-side aluminum sample. These indications were not found on the driver-side aluminum sample (Fig. 9).

**Fig. 6** Micrograph of passenger-side aluminum sample showing excessive oxidation. 500×

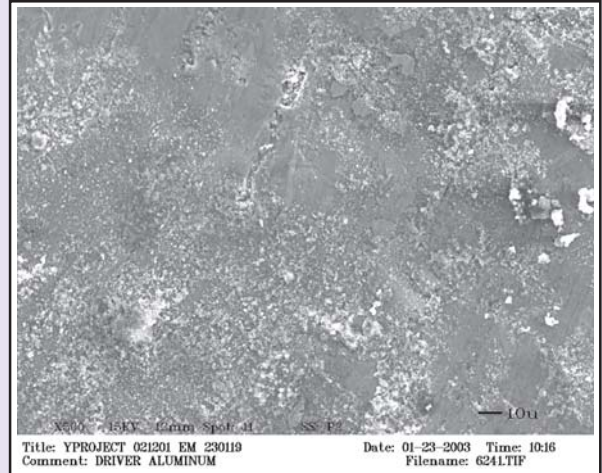
**Fig. 9** Micrograph of driver-side aluminum sample. 500×

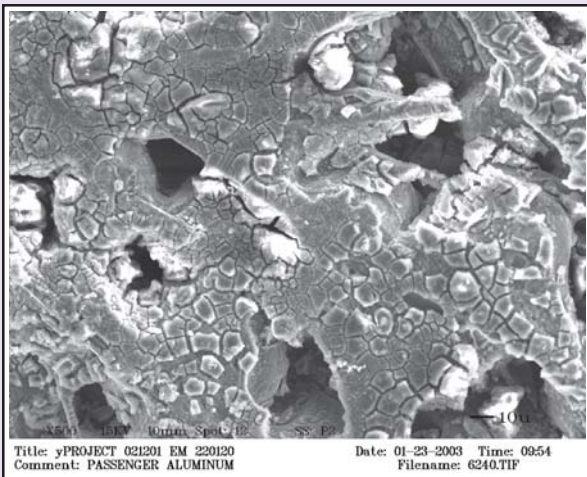
**Fig. 7** Micrograph of passenger-side aluminum sample showing porosity. 500×

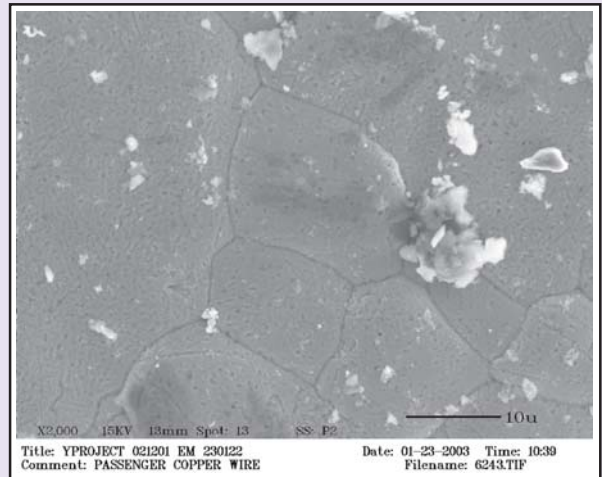
The melting and nominal recrystallization temperatures for copper are 1450 and 415 °C (2640 and 780 °F), respectively. The temperature of the copper electrical wiring near the passenger-side engine valve cover was 415 to 1370 °C (780-2500 °F), while the temperature of the copper electrical wiring near the driver-side engine valve cover was less than 415 °C (780 °F).

This was established by noting grain growth (Fig. 10) and grain-boundary degradation (Fig. 11) on the passenger-side copper sample. These indications

**Fig. 10** Micrograph of passenger-side copper sample showing grain growth. 2000×

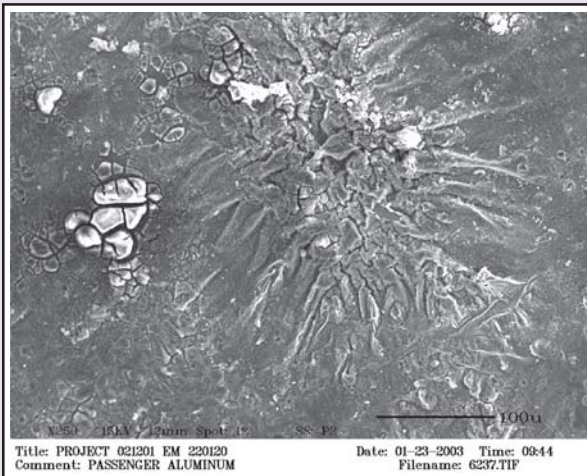
**Fig. 8** Micrograph of passenger-side aluminum sample showing incipient melting. 250×

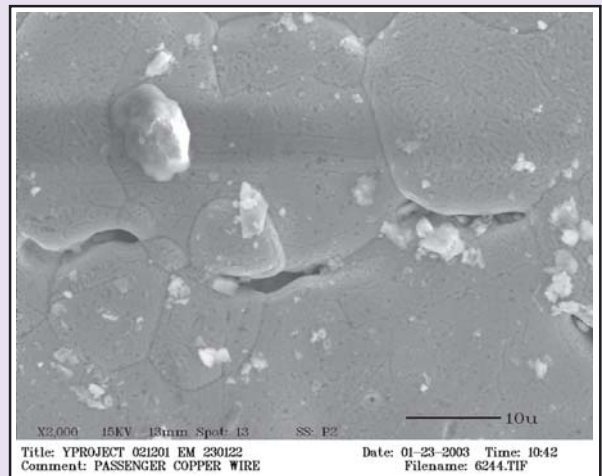
**Fig. 11** Micrograph of passenger-side copper sample showing grain-boundary degradation. 2000×

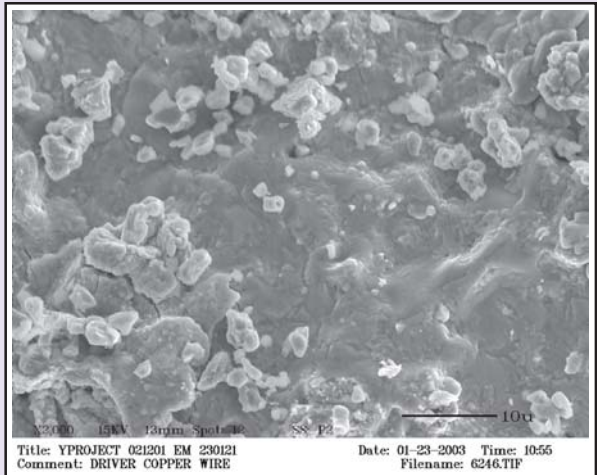
Fig. 12 Micrograph of driver-side copper sample. 2000x

were not found on the driver-side copper sample (Fig. 12).

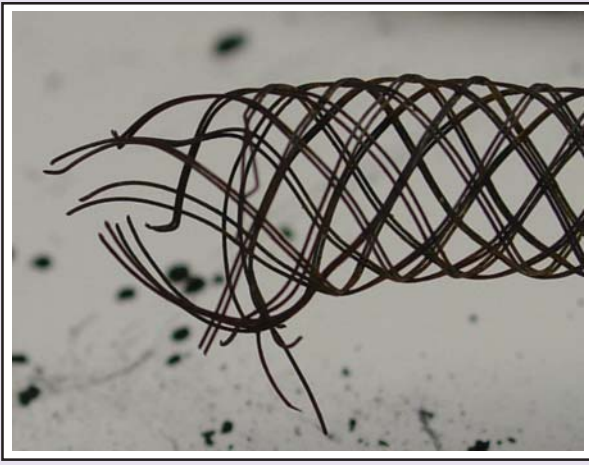
Fig. 13 Melted end of liquid propane feed line to mixer in engine compartment

The melting temperature of iron is approximately 1535 °C (2800 °F). The steel braided tubing for transporting liquid propane to the mixer in the engine compartment disappeared due to volatilization of the rubber coating and melting of the end of the reinforcing steel braid (Fig. 13). This was the only area to attain this high of temperature, which indicated that a steady supply of fuel must have been available.

The LP fuel line ran through the front passenger wheel well and it was opined that abrasion by road debris created a hole in the line.

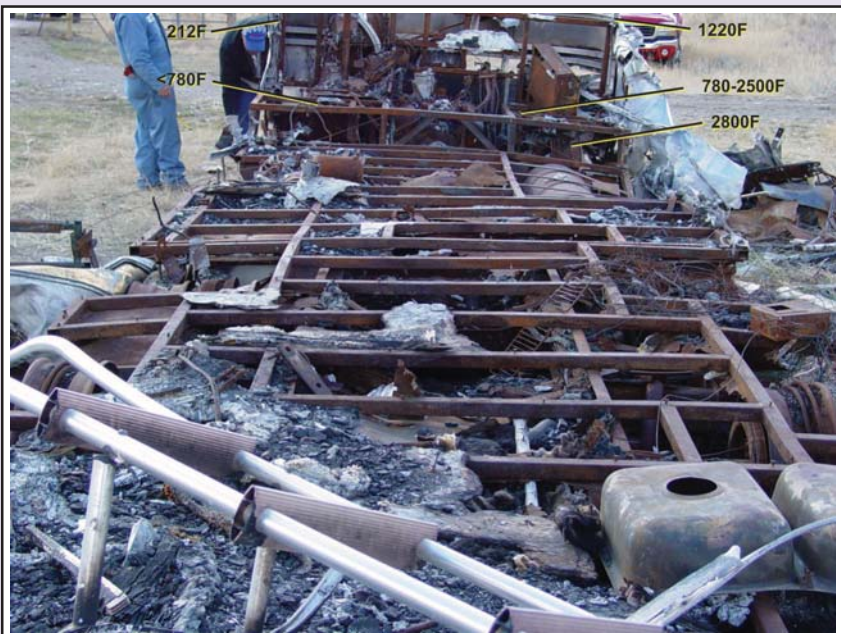
Fig. 14 Overall view of recreational vehicle with approximate maximum fire temperatures noted

These results are summarized in Fig. 14, which depicts the temperatures experienced by the various components and their locations. This analysis shows that the maximum temperatures during the fire were experienced by materials on the passenger side near the engine, suggesting that the fire fuel source was near the engine compartment, and is consistent with the origination site being in the passenger-

side front wheel well due to abrasion of the LP fuel line behind the front wheel.
