Failure Analysis of Brass Bolt from Mausoleum

W. Reitz

Brass is usually considered to be a good candidate material for use in a nonaggressive corrosion environment. Brass 260 was used in a rural environment (at a mausoleum) as fixturing hardware that holds etched marble slabs that cover the interment region. After 12 years of service, the bolts began breaking, and the marble slabs crashed to the ground. Failure analysis investigation showed that “seasonal cracking” occurred due to interaction of the bolt with moisture and fertilizer. The company that designed the mausoleum hardware believed that the bolt manufacturer was at fault. However, the only specification given to the bolt manufacturer indicated alloy and dimensions. The bolts were replaced at considerable cost, proving once again that even a seemingly simple component can prove to be costly if not designed by the proper engineer.

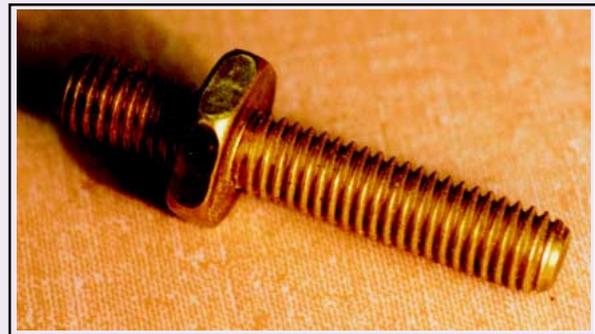
Fig. 1 Unused bolt, $\frac{3}{8}$ 16 threads per inch by $\frac{1}{4}$ in. (9.5 by 57.2 mm) long, with cold-worked nut integral with bolt

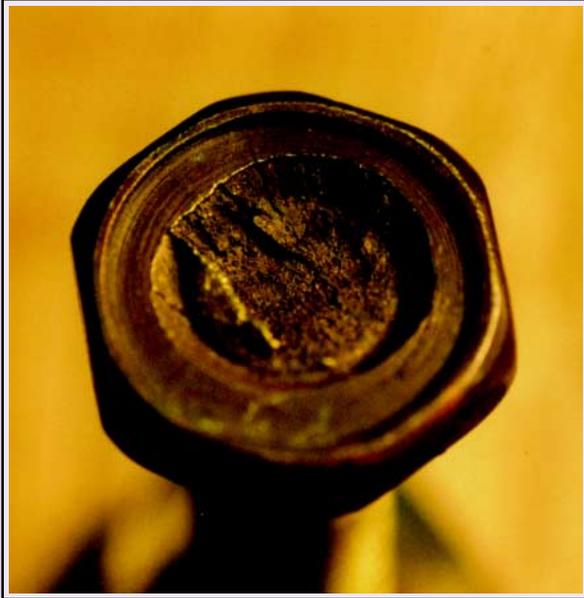
Several fractured bolts were provided from the mausoleums that had been in service for 8 to 12 years. They all exhibited the same fracture appearance, and typical bolts are shown in Fig. 3 and 4. In all instances, the short, threaded end of the bolt fractured at the top of the nut. Table 2 lists the hardness of each bolt. These values were obtained on one end of each bolt. The minimum and maximum values were 82 and 97 R_B , respectively. A sample of blank material was obtained from the bolt manufacturer. The hardness of the blank material prior to final forging was softer, as was expected.

Fig. 3 As-received fractured bolt (M-1; M, mausoleum located in Michigan)

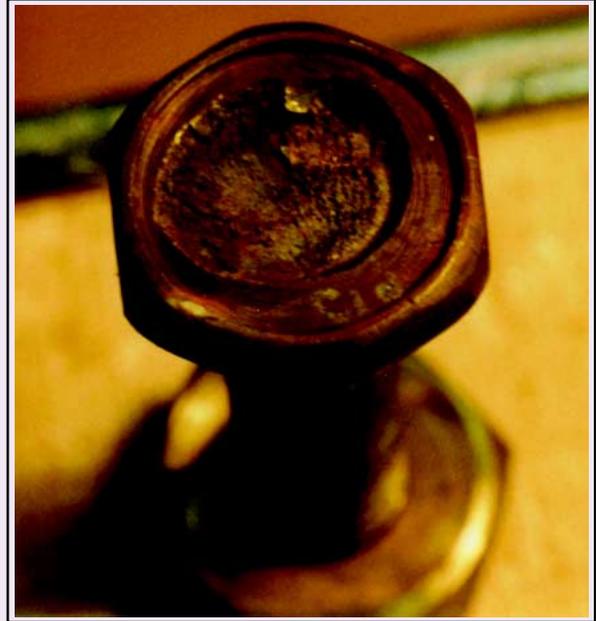
Fig. 4 As-received fractured bolt (P-3; P, mausoleum located in Pennsylvania)

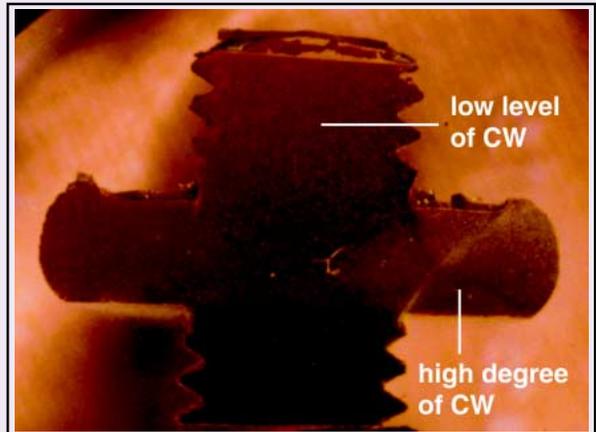
Several bolts were sectioned through the forged nut and evaluated metallographically. Figure 5 shows a typical macroscopic view of the sectioned bolts. There appeared to be a difference in grain structure related to the manufacturing process; heavier cold work and a corresponding higher strength appeared in the forged nut region.

Fig. 5 Macroscopic view of forged bolt showing various levels of cold work

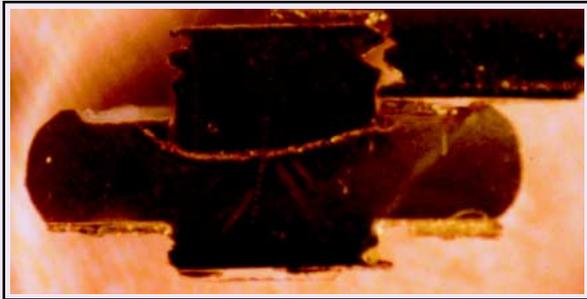
Figures 6 and 7 show the macroscopic cross sections of two used bolts that were retrieved from the mausoleum prior to fracture. (Several bolts were retrieved at random. Two bolts were severely cracked, while the remaining bolts were free of cracks or defects.) These cracks followed the same path as the bolts that failed in service (Fig. 8). The cracks

in Fig. 6 and 7 followed the interface between the duplex grain structures. This interface between large grains and small grains causes the grain boundaries at the interface to line up, which facilitates crack propagation.

Fig. 6 Cracked bolt (P-12)

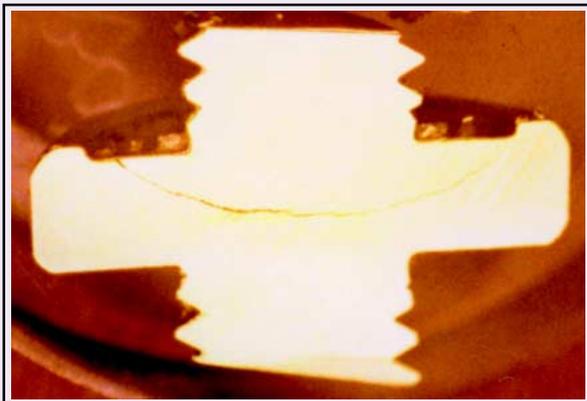
Fig. 7 Cracked bolt (P-8)

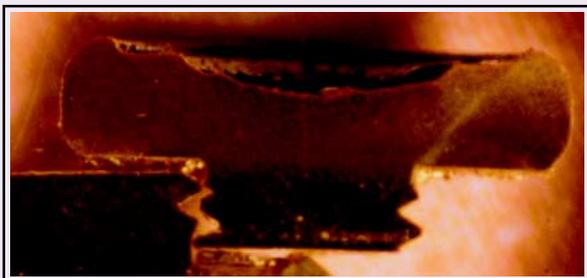
Fig. 8 Bolt that failed in service

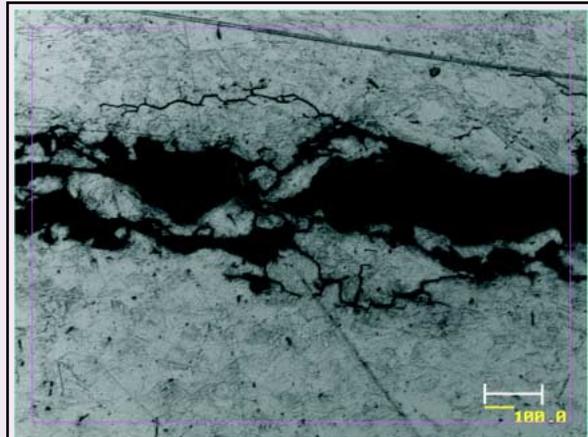
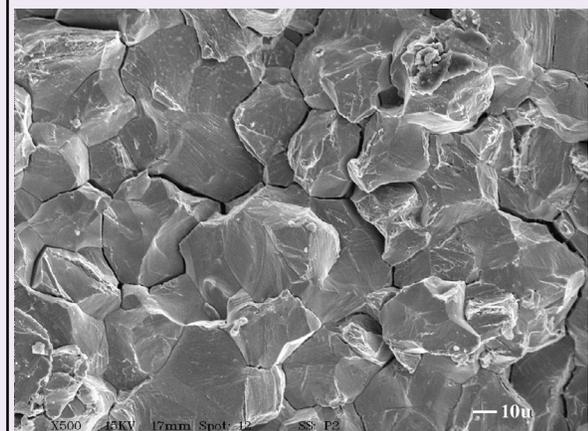
Intergranular cracking was readily apparent, as shown in Fig. 9(a) and (b). The main crack is intergranular, and secondary intergranular cracking is present in numerous locations. Stress-corrosion

Fig. 9 (a) Intergranular cracking via optical microscopy. Scale marker is 100 μm . (b) Intergranular cracking via scanning electron microscopy. Scale marker is 10 μm .

cracking (SCC), also known as seasonal cracking, occurred on the failed bolts.^[2] Seasonal cracking was first observed in brass cartridge cases in India that were adjacent to a horse stall during the monsoon season. This was the first evidence that ammonia caused SCC in brass. Three criteria are necessary for SCC to occur: the presence of stress, a corrosive environment, and a material susceptible to SCC. Brass is known to be susceptible to SCC when ammonia is present. Ammonia can be present in the atmosphere in minute quantities that are difficult to measure. Bacteria as well as fertilizer can be sources of ammonia. Another environmental concern is an alkaline atmosphere (lithium, sodium, potassium, rubidium, cesium) that may leach from the concrete during rainy weather. The stress is present due to residual stress from cold forging and/or overtightening of the jam nut during assembly.^[3] Witnessing the retrieval process revealed that a strong groundskeeper worked hard to loosen the bolts. This observation is consistent with overtightening during installation. All of the failed bolts came from areas of the mausoleum that were exposed to the environment: for example, wind, rain, and birds. Overtightening of the bolts is completely unnecessary. It may not be obvious from the assembly drawing (Fig. 2), but the weight of the marble slab is carried by the brackets underneath. The bolts in question (item 11 in Fig. 2) do not carry any load; they merely keep the marble slab in a vertical position.

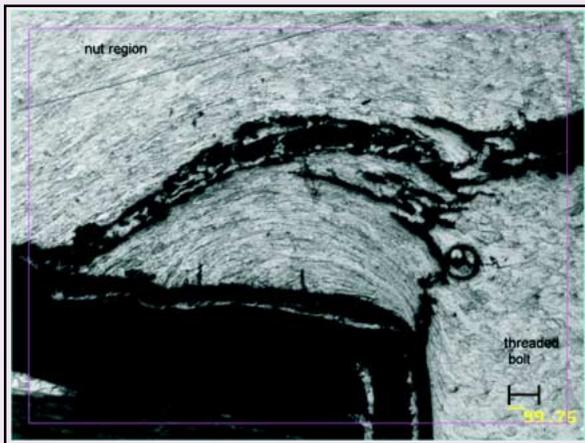
Fig. 10 Heavily cold-worked grains. Scale marker is approximately 100 μm .

Stress-corrosion cracking initiated at the heavily cold-worked transition region between the forged nut and the outside diameter of the threaded bolt, as shown in Fig. 10. This region possesses high residual stress. The cracking continued along the interface between the high-cold-worked and low-cold-worked regions. The amount of ammonia in the atmosphere to cause seasonal cracking is not known.^[4] The amount may be very small, and cracking may occur after prolonged exposure. Intergranular cracking is prevalent.^[5]

- Minimize residual stress: Reduce torque values used in assembly at the mausoleum; perform stress-relief annealing after cold forming of the bolt.
- Minimize the presence of a corrosive environment (rainwater leaching concrete chemicals and carrying fertilizer residue and bird droppings).

- Change the bolt material: Consider low-zinc brass, tough-pitch copper, or oxygen-free high-conductivity copper.
- Some of the remaining bolts in service will continue to fail due to SCC, especially those that are exposed to rain.
